Naval Research Laboratory
Washington, DC 20375-5320

Lithium-Ion Battery Failure: Effects of State of Charge and Packing Configuration

August 22, 2016

NRL/MR/6180--16-9689

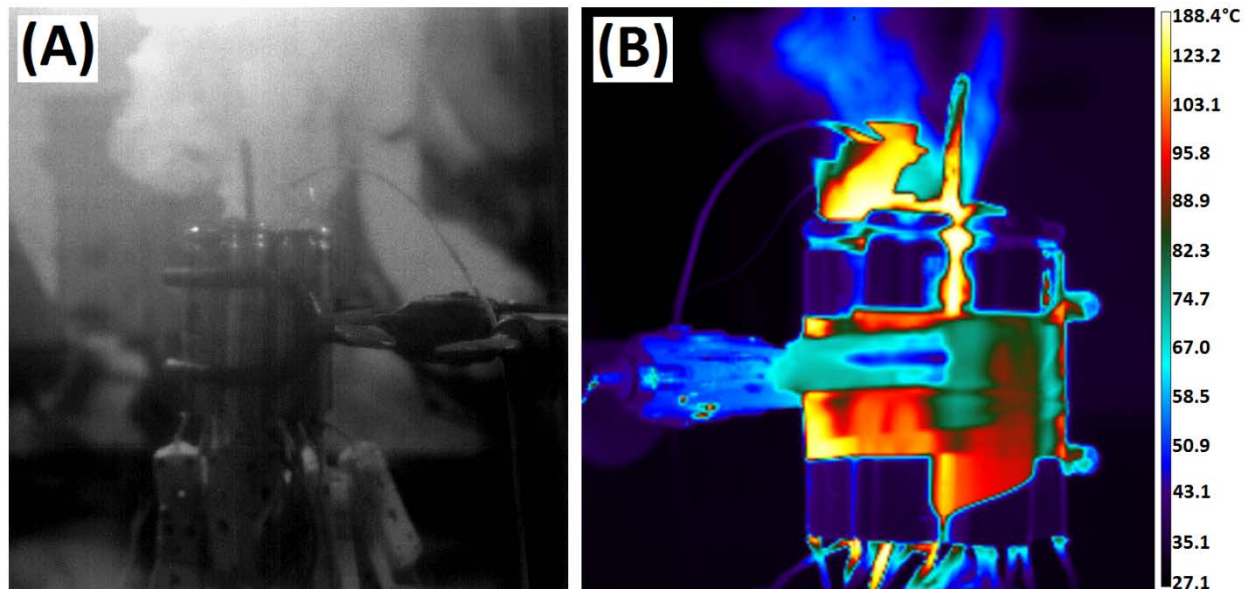
A hexagonal arrangement of cells was constructed for all horizontal failure tests, as illustrated in Fig. 1A. Images from the optical high speed (HS) and infrared (IR) cameras during the failure event using an active cell at 30% SOC are shown in Figure 3. Two separate venting occurrences were observed, separated by around 4 minutes. The cell initially vented a small amount of fluid (likely gas and/or electrolyte), followed by a brief lull while the heater cell continued applying heat. Finally, the cell began vigorously smoking and ejecting fluid rapidly, although no fire, flame or sparks were generated likely as a result of the low SOC of the battery. Once the event had fully exhausted the battery contents, the heater cell was turned off and the assembly was allowed to cool slowly to room temperature while the chamber was safely vented of all hazardous gases.

Figure 3. (A) High speed and (B) IR camera images for hex package 30% SOC failure test.

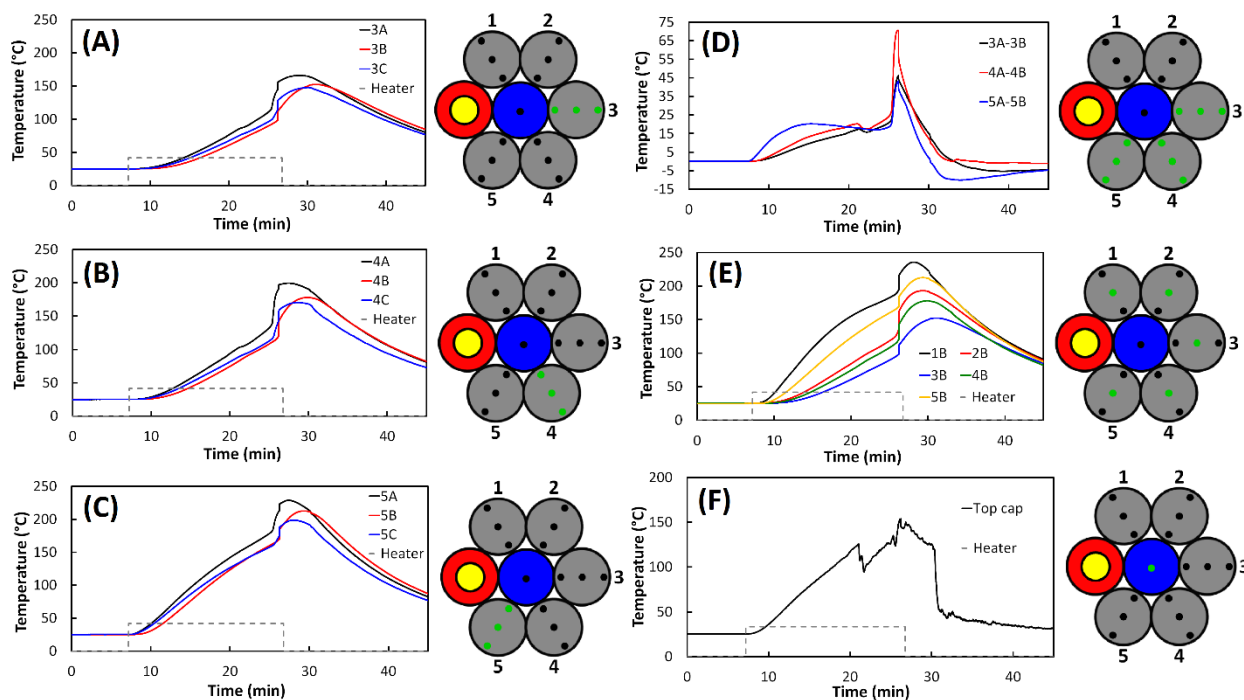
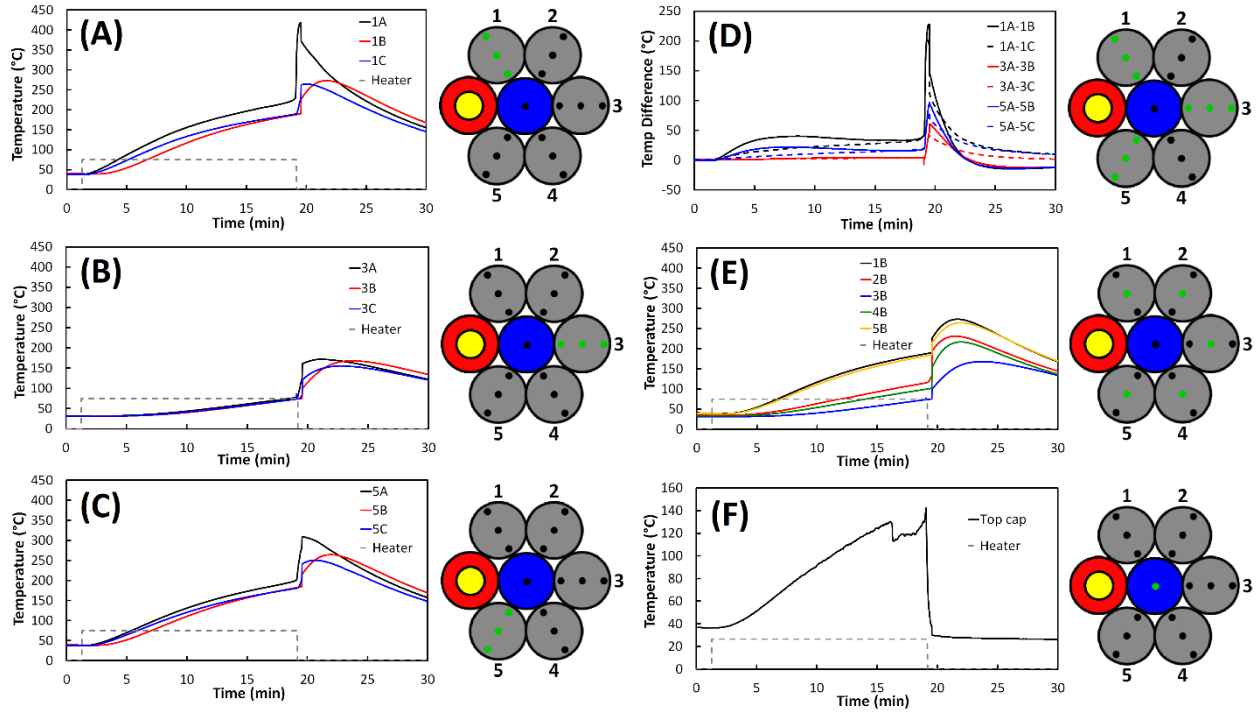
Figure 4 shows temperature vs. time data for the surrogate and 30% SOC active cells, as well as temperature differences for internal surrogate cell thermocouples. The maximum temperature at the top of the active cell was recorded to be 126°C (Fig. 4F) at the moment of the initial venting, at which point the thermocouple became detached from the package. Surrogate

Figure 4. (A) through (C) show surrogate cell temperatures vs. time; (D) instantaneous internal temperature distributions; (E) 'B' position thermocouple temperatures vs. time; and (F) active cell top thermocouple temperature vs. time for hex package 30% SOC failure test.

cell internal temperatures reached maximum values of 148-236°C (Fig. 4A-C) during the final battery failure, illustrating the extreme capacity for energy transfer to adjacent cells during a single cell failure in a multi-cell pack, even at a low SOC. Instantaneous temperature differences reached as high as 46-71°C at the point of failure (Fig. 4D), demonstrating large internal temperature gradients which can cause hot spots and further battery failure in active cells. Finally, the largest temperatures were observed in surrogate cells 1 and 5 (Fig. 4E), which was expected since they were closest to the heater cell. During the initial heating stage, surrogate cells 1 and 5 received more heat due to direct contact with the heater cell than the other three surrogate cells. However, once the failure event began, all five surrogate cells experienced a similar degree of temperature rise from the heat expelled by the failing active cell since the contact was identical for all surrogate cells to the active cell. After several minutes of cooling, all five surrogate cells reached approximately the same temperature before returning to ambient conditions.

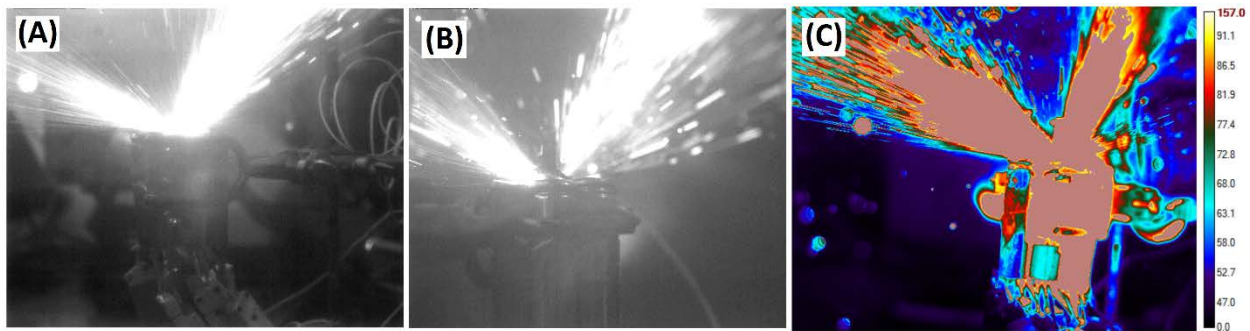
Hex package HS and IR camera images with a 100% SOC active cell are shown in Figure 5 with temperature-time graphs shown in Figure 6. Once again, two distinct events were observed: an initial venting occurred releasing a small amount of electrolyte, followed by a full failure around 2-3 minutes later. In this case, the failure event was much more energetic than the 30% SOC test and involved sparking before a long period of smoking. The active cell top cap thermocouple reached a maximum temperature of 130°C during the initial venting (Fig. 6F), and similarly to the 30% SOC test, slightly detached from the cell making temperature readings during the final failure event inaccurate. As expected, surrogate cells 1 and 5 again showed the highest temperatures among all surrogate cells (Fig. 6E) due to proximity to the heater cell, reaching 250-418°C maximum internal temperatures, compared to only 155-231°C maximum temperatures for surrogate cells 2, 3 and 4 (Fig. 6A-C). Instantaneous surrogate cell temperature differences shown in Fig. 6D were as large as 82-228°C for surrogate cells 1 and 5 during the failure event, and even reached 19-40°C during the heating period before failure. The greater output of energy during failure of the 100% SOC cell resulted in much greater internal temperature distributions than the 30% SOC cell. Additionally, during the failure event liquid was observed to bubble from the top of the active cell and drip down and around the other cells in the package. This liquid was likely not electrolyte considering the extremely high temperatures present inside the failing battery that caused vaporization, decomposition, or combustion of the electrolyte, but rather was probably

Figure 5. (A) and (B) show high speed camera images, and (C) shows IR camera images for hex package 100% SOC failure test.

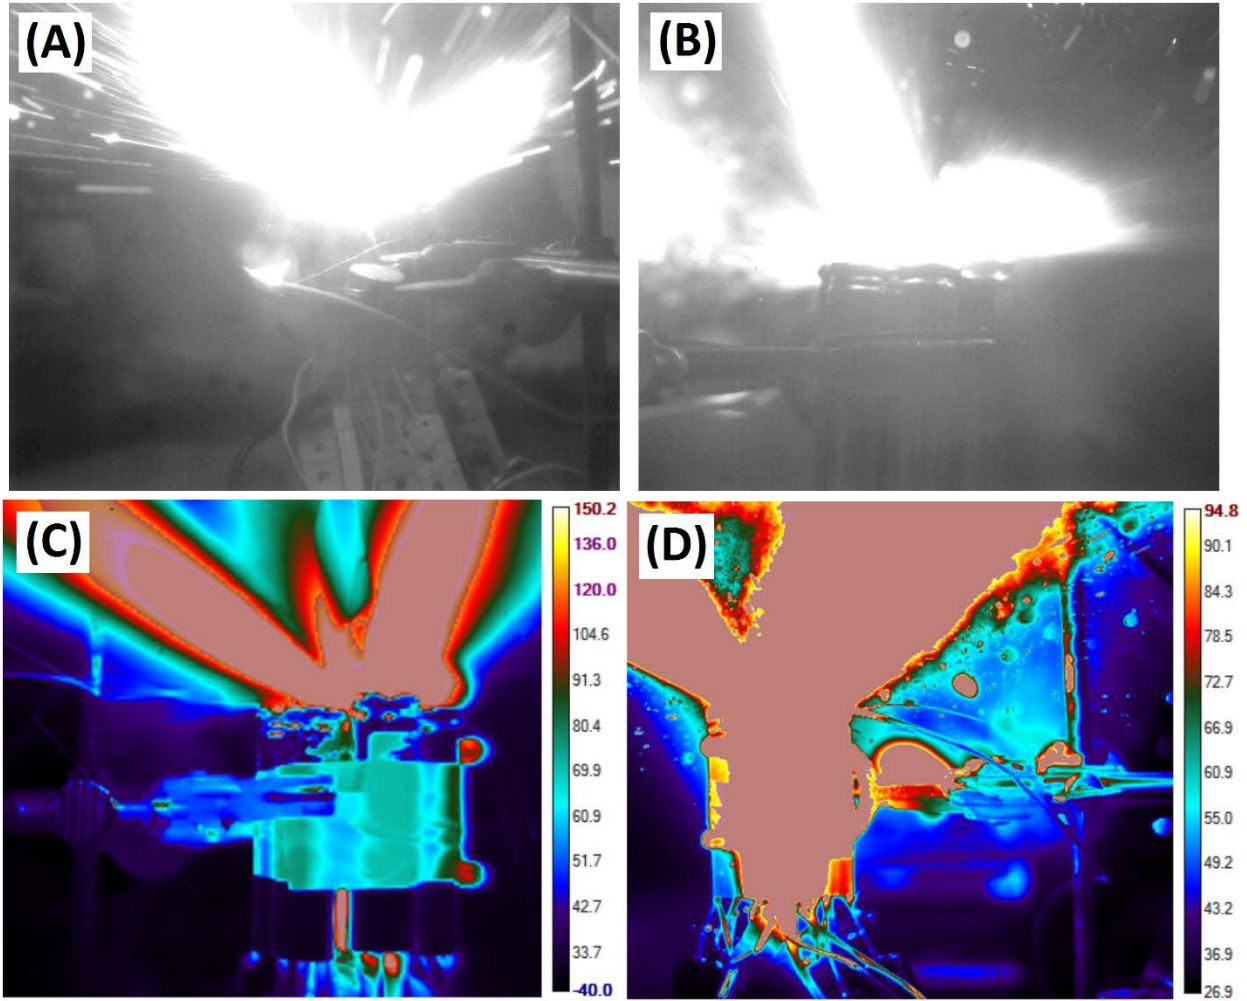
Figure 6. (A) through (C) show surrogate cell temperatures vs. time; (D) instantaneous internal temperature distributions; (E) 'B' position thermocouple temperatures vs. time; and (F) active cell top thermocouple temperature vs. time for hex package 100% SOC failure test.

melted metals from the electrode materials (aluminum, copper, cobalt, and/or lithium) escaping and flowing out due to large internal pressures. This hot molten metal dripping around the active and surrogate cells may also have contributed to the extremely large temperatures seen in Fig. 6 compared with the 30% SOC test.

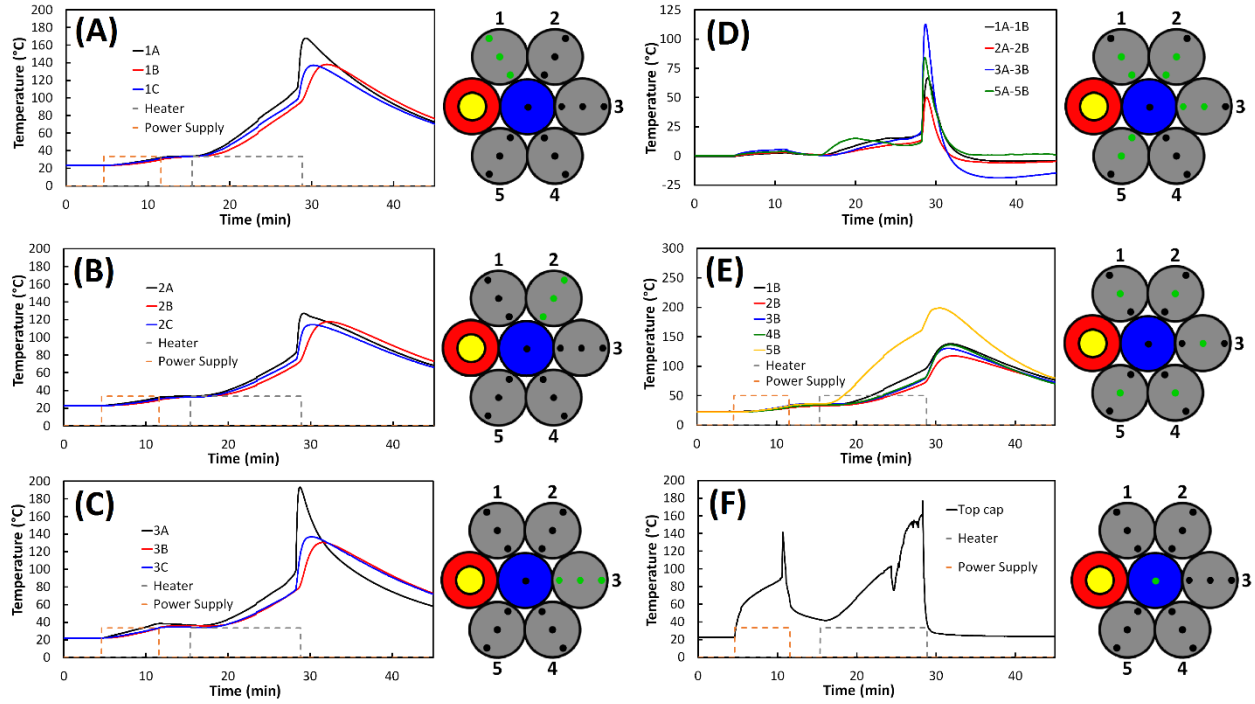
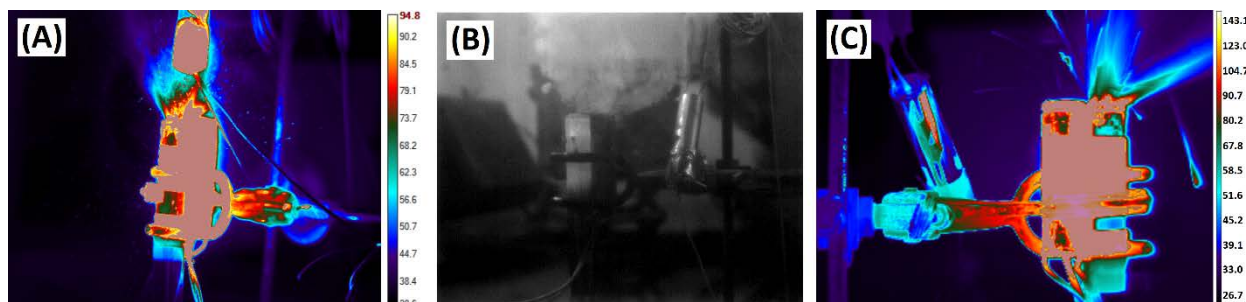
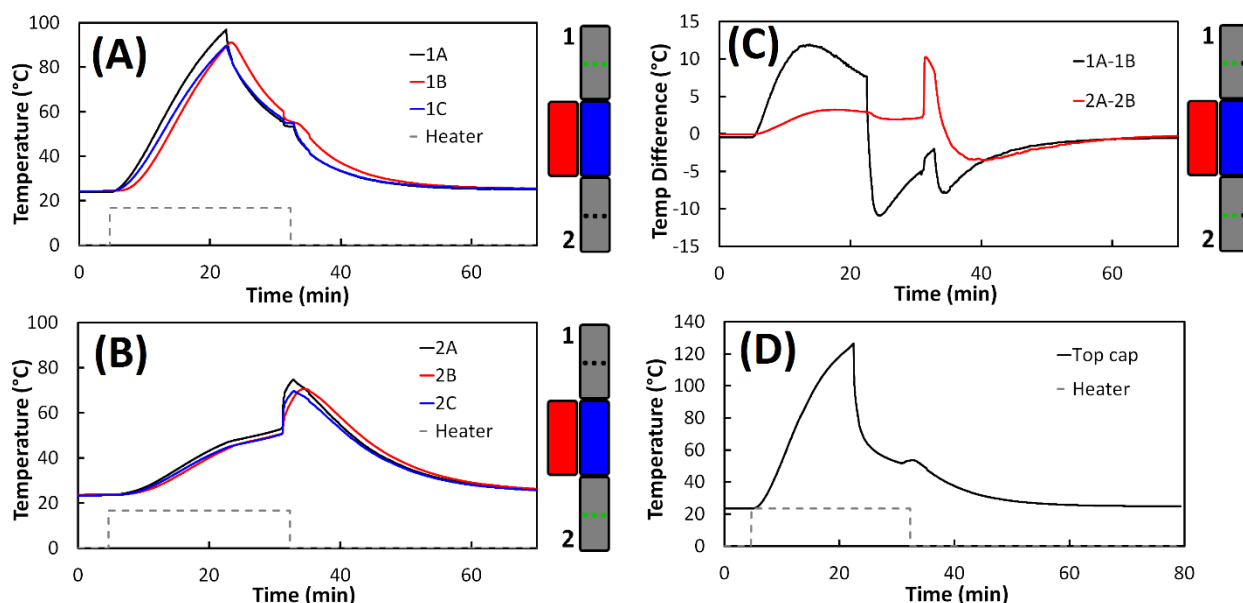
Figures 7 and 8 show HS and IR camera images, as well as temperature vs. time data, for the hex package with an overcharged-overheated active cell, respectively. In this test, the active cell was severely overcharged until the safety vent activated, causing the battery to permanently trip to open circuit. At this point, no current was able to be passed through the battery making pure overcharge failure an impossibility. For this reason, the heater cell was still used to bring the cell to the point of catastrophic failure. Similarly to the 100% SOC test, the overcharged battery produced a large amount of energy, sparking, and the force of the event caused the cell package to dislodge from the clamp holding it in place. The initial venting that took place when the battery was overcharged also resulted in the top thermocouple becoming detached, making accurate measurements of the top of the active cell during the ultimate failure event difficult. The maximum temperature observed from the top thermocouple on the active cell during the initial overcharge-induced venting was 141°C (Fig. 8F), and surrogate cell temperatures surprisingly only reached 114-259°C (Fig. 8A-C) during the failure event. These values were comparable to the 30% SOC test rather than the 100% SOC test, which was unexpected considering the greater level of stored energy and violence observed during the failure from the overcharged cell. It is possible

Figure 7. (A) and (B) show high speed camera and (C) and (D) IR camera images for overcharged hex package failure test.

that unlike the 100% SOC test, where hot molten liquid dripped around the cell package and inflated the temperature data, the majority of energy from the overcharged cell propagated vertically and in a very short time period such that the adjacent surrogate cells were not as heavily impacted. This short vertical burst may also be the reason that unlike the previous tests, there was not as dramatic a difference between surrogate cells 1 and 5 compared with the other three, save for the obvious spike observed with thermocouple 5B in Fig. 8E. The 30% SOC failure event, while less energetic, lasted longer during the period of smoking and venting which may explain why the overall maximum temperatures were close in magnitude. Finally, the explosive nature of the overcharged cell resulted in internal temperature distributions between 51-111°C (Fig. 8D) during failure, which were greater than the 30% SOC test results.

Figure 8. (A) through (C) show surrogate cell temperatures vs. time; (D) instantaneous internal temperature distributions; (E) 'B' position thermocouple temperatures vs. time; and (F) active cell top thermocouple temperature vs. time for overcharged hex package failure test.

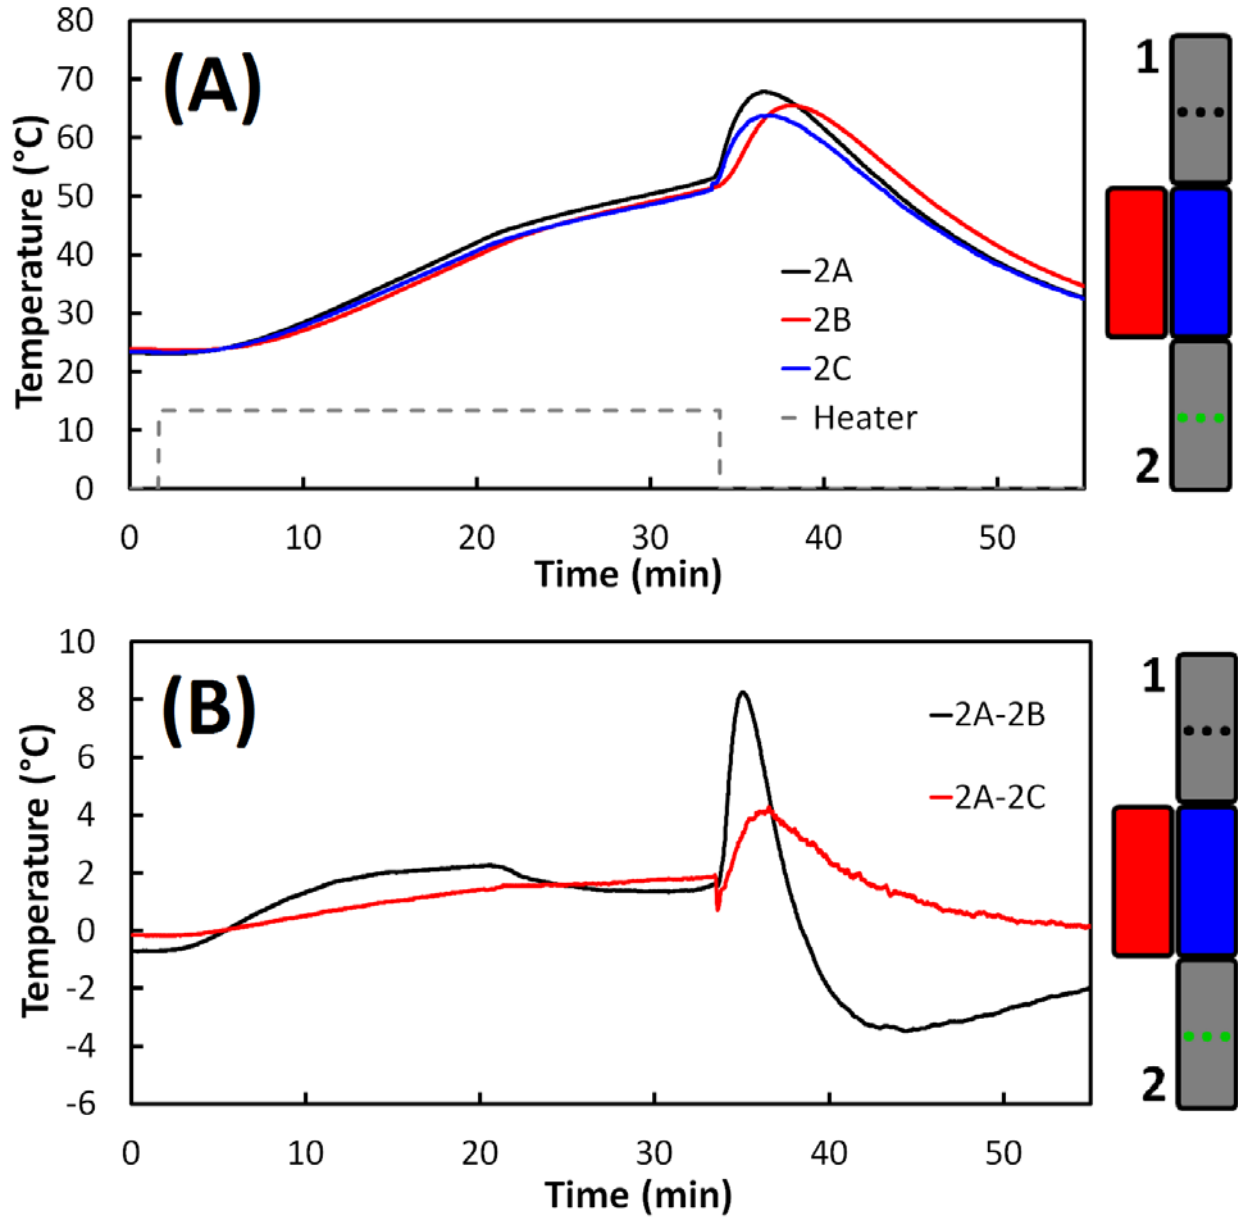
Figure 10. (A) and (B) show surrogate cell temperatures vs. time; (C) shows instantaneous internal temperature distributions; and (D) shows active cell top thermocouple temperatures vs. time for vertical package 30% SOC test.

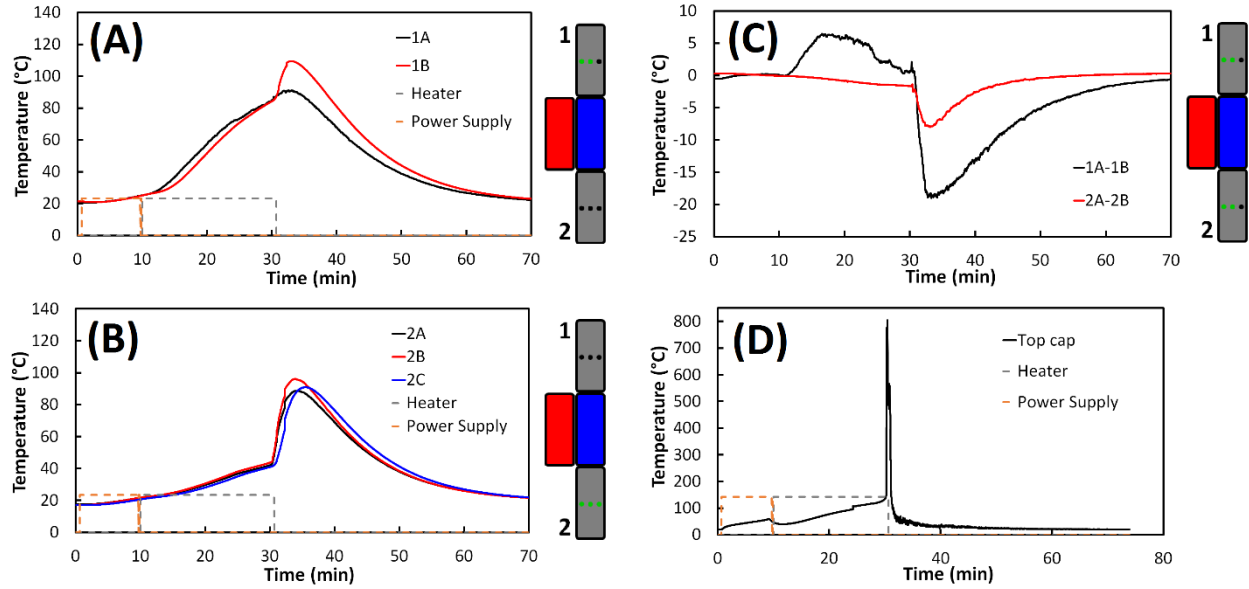
overcharge venting fortunately did not cause either the top surrogate cell or top thermocouple to dislodge, allowing measurements to be made throughout the experiment. The maximum top thermocouple temperature during the initial venting was 107°C, and there was only a negligible rise in surrogate cell temperature before the heater cell was turned on. During the catastrophic failure event, the top thermocouple reached a staggering maximum temperature of 805°C (Fig. 14D), and the top surrogate cell registered 91-109°C (Fig. 14A) before it was ultimately ejected from the package during the intense sparking, flames, and fluids being spewed from the active cell during failure. The bottom surrogate cell reached 89-96°C (Fig. 14B) which was higher than the previous two vertical package tests and was likely a result of a much greater energy output during

failure due to overcharged conditions. Despite the increased energy output, however, a maximum internal temperature distribution of just 8-19°C was seen (Fig. 14C), consistent with all vertical package tests performed in this study.

Figure 14. (A) and (B) show surrogate cell temperatures vs. time; (C) shows instantaneous internal temperature distributions vs. times; and (D) shows active cell top thermocouple temperature vs. time for overcharged vertical package test.
